Inspection for Body Damage

Transmission Routes of Impact

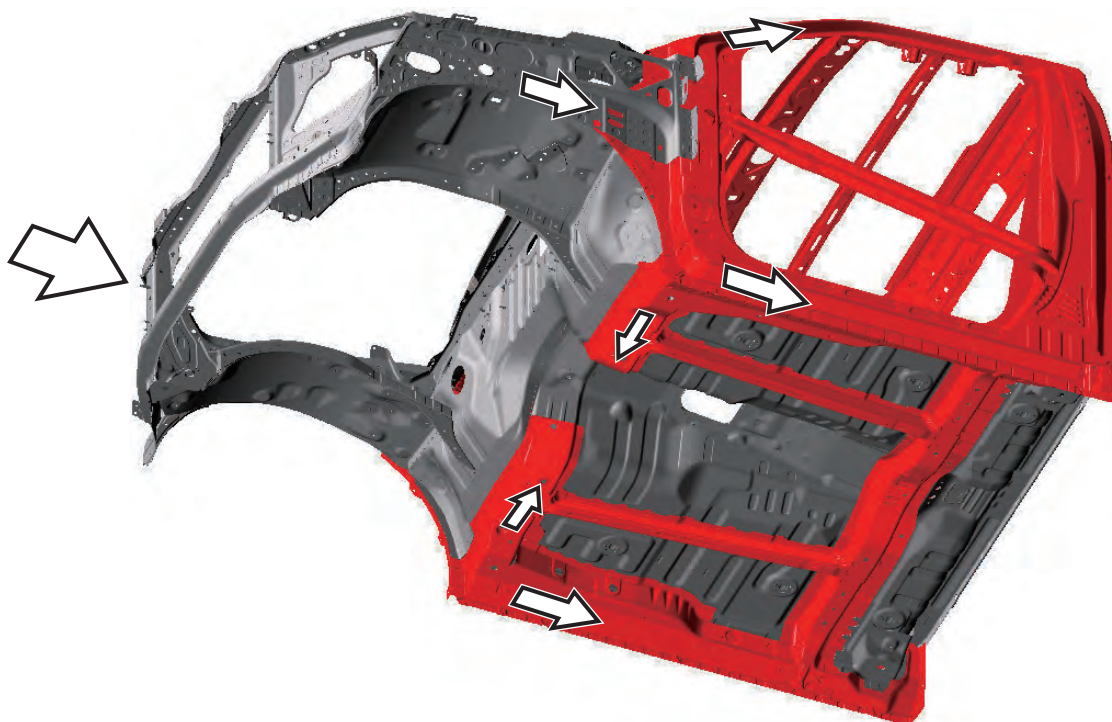
1. Frontal Collision

Regular Cab

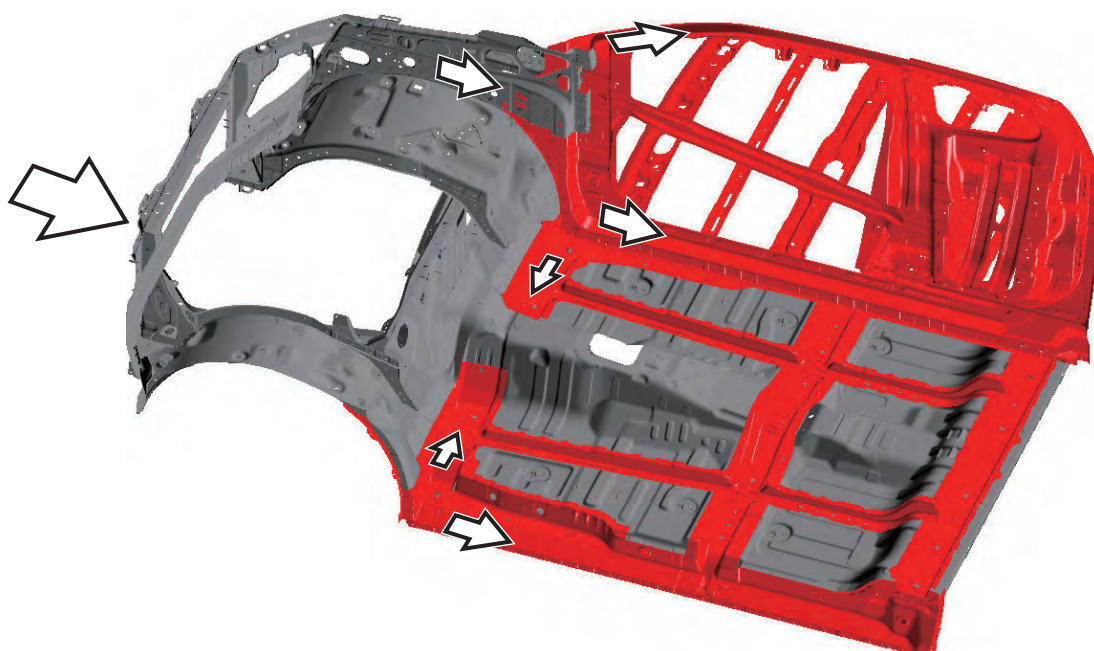
Extended Cab

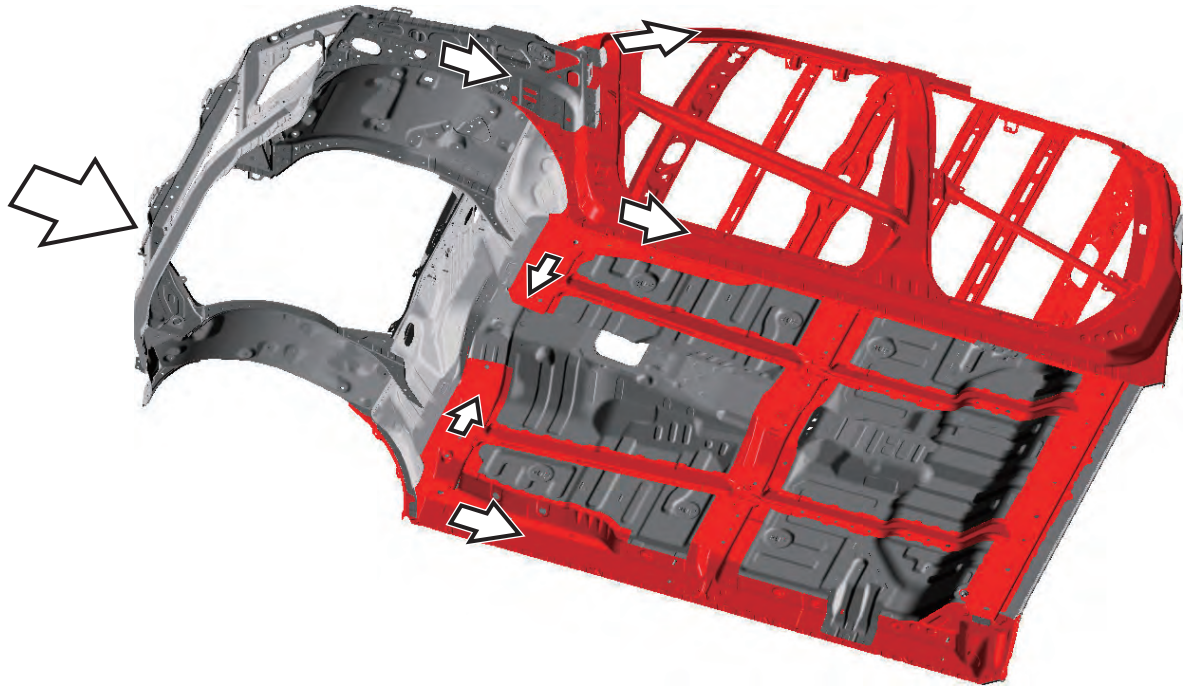
Crew Cab

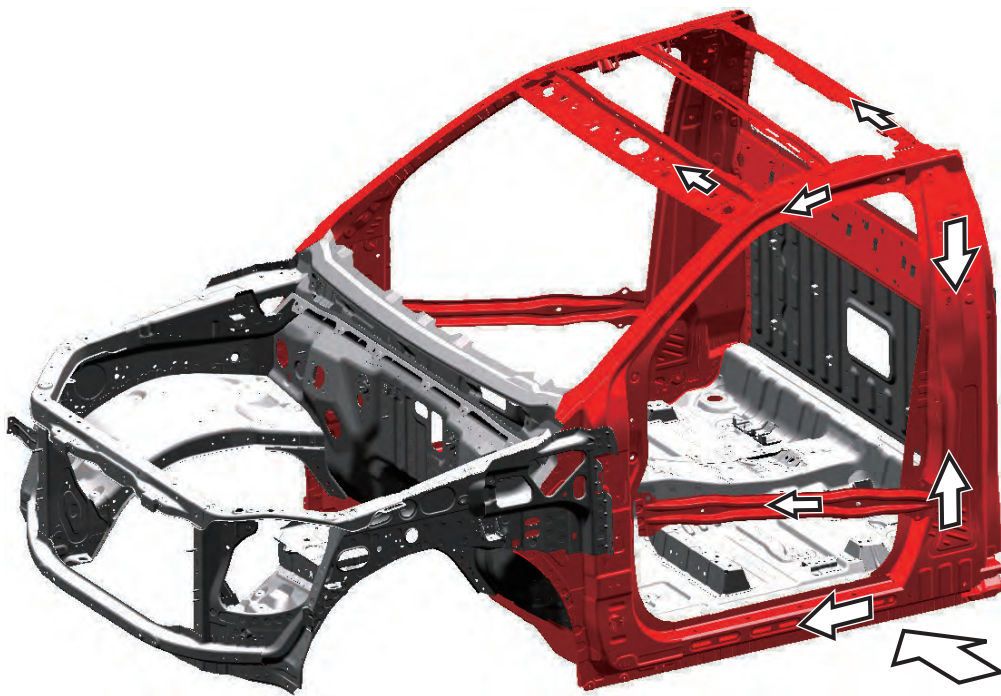
2. Sideward Collision Regular Cab

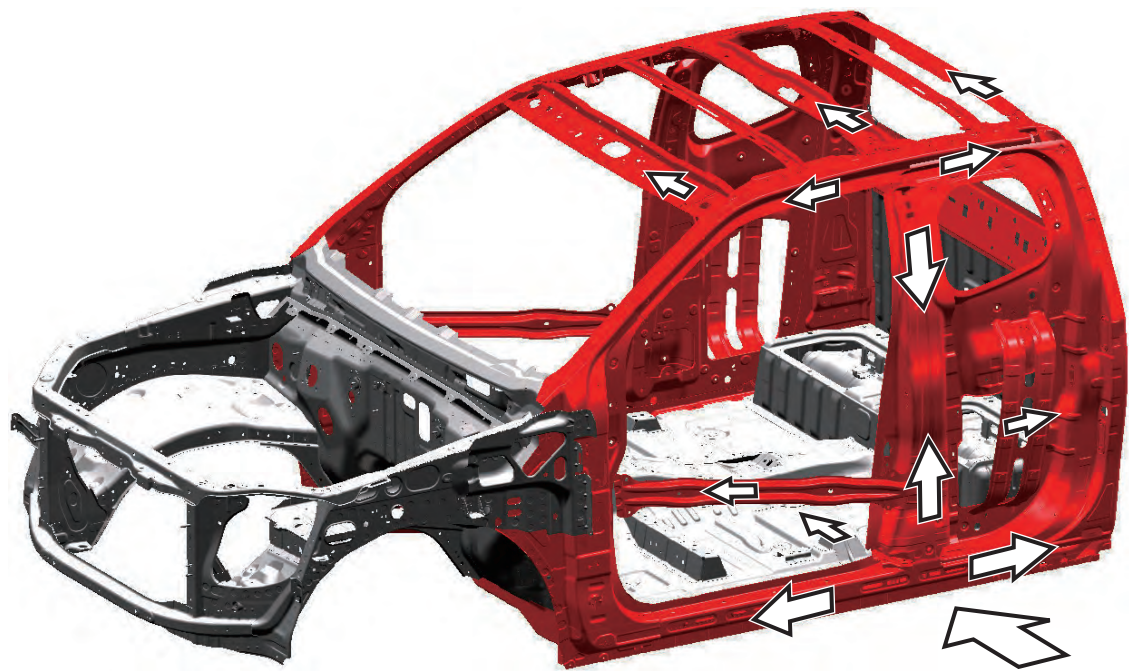
Extended Cab

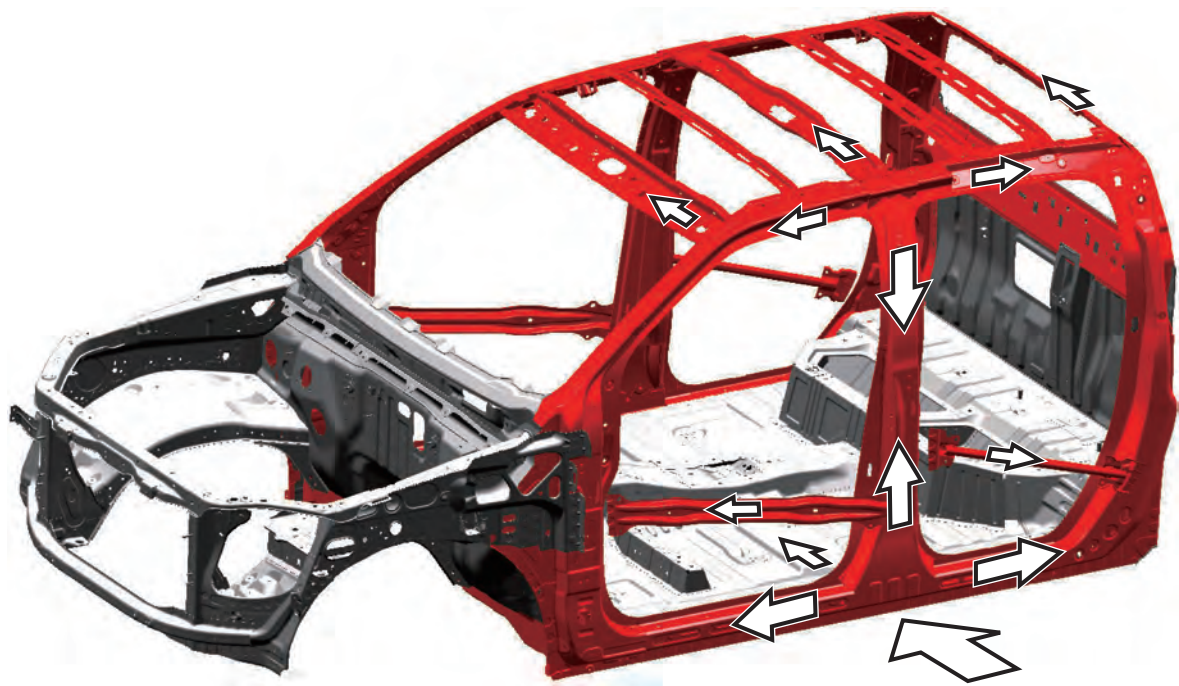
Crew Cab
